BMP Project Fact Sheet

In-Stream Stormwater Management

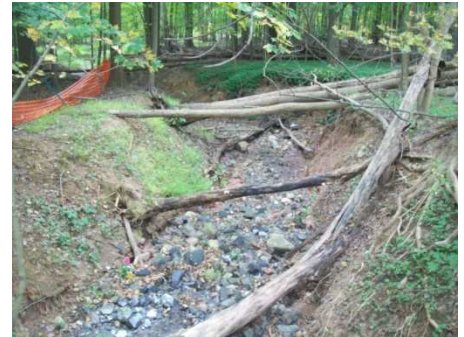
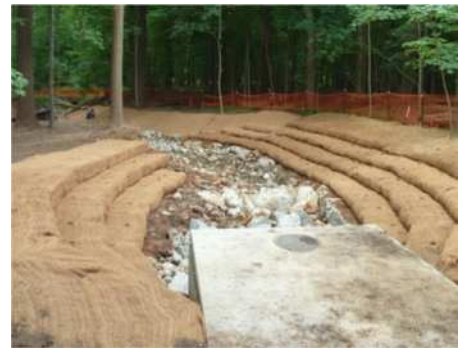
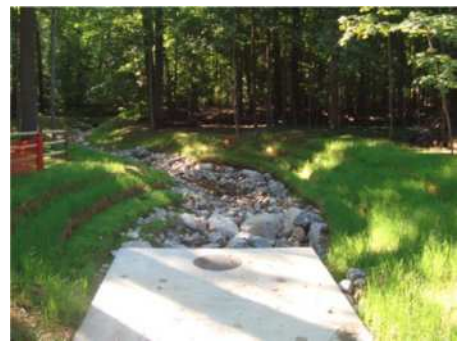
The stormwater retrofit used a large concrete vault to capture primary coarse solids from the local road network and stormwater system. The flow leaving the vault entered a pre-formed scour hole, then three grade control structures lined with rounded river stone.

The stream restoration included the creation of a narrow riparian terrace to slow flows and provided additional flood storage, and step pools to allow settling of particulates and infiltration.

The project utilized several bank stabilization techniques, including bioengineering soil wraps with boulder toe protection, erosion control matting, and riprap stabilization with 12" diameter stone.
